UNITED STATES ANTARCTIC PROGRAM

SOUTH POLE

SATELLITE COMMUNICATIONS UPDATE

Nicolas S. Powell 15 July 2002

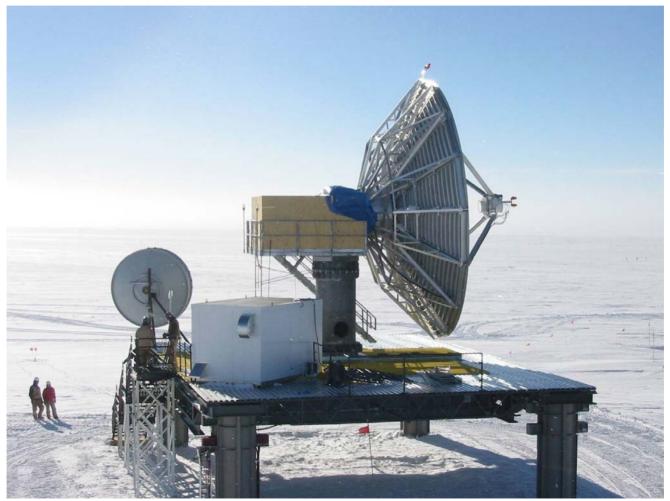
South Pole SATCOM GOES - Status

- Lightning strike 5 Jul at FL teleport caused significant damage
 - 20 m antenna not operating
 - TBD damage to electronics
 - Currently using small back-up system 128kbps out & 176 kbps in
 - Restoration to FOC unknown
- Currently using 3 m GOES-BA installed last season on SPMGT platform - damaged feed & poor design precludes use of SPMGT
- Uses different modem, & SSPA than MARISAT
- Original SPMGT Modems to be replaced & incompatible with CONUS modems
- SPMGT SSPA can't provide power required to close link using GOES-BA
 - May work with SPMGT Antenna (TBD)
 - Working with Supplier
- FOC GOES-BA data rate 256 kbps out, 512 kbps in

- Integrate into SPMGT
 - Correct SSPA problem
 - Replace modems at South Pole and FL Teleport
 - Install replacement SPMGT feed
 - Install remote SPMGT antenna/GOES-BA switches and controller - integrate into M&C system
 - Modify M&C macros
- Establish best throughput data rates
