U.S. Antarctic Program Ship Resupply 2005/2006

Presentation to ARVOC
June 14, 2006

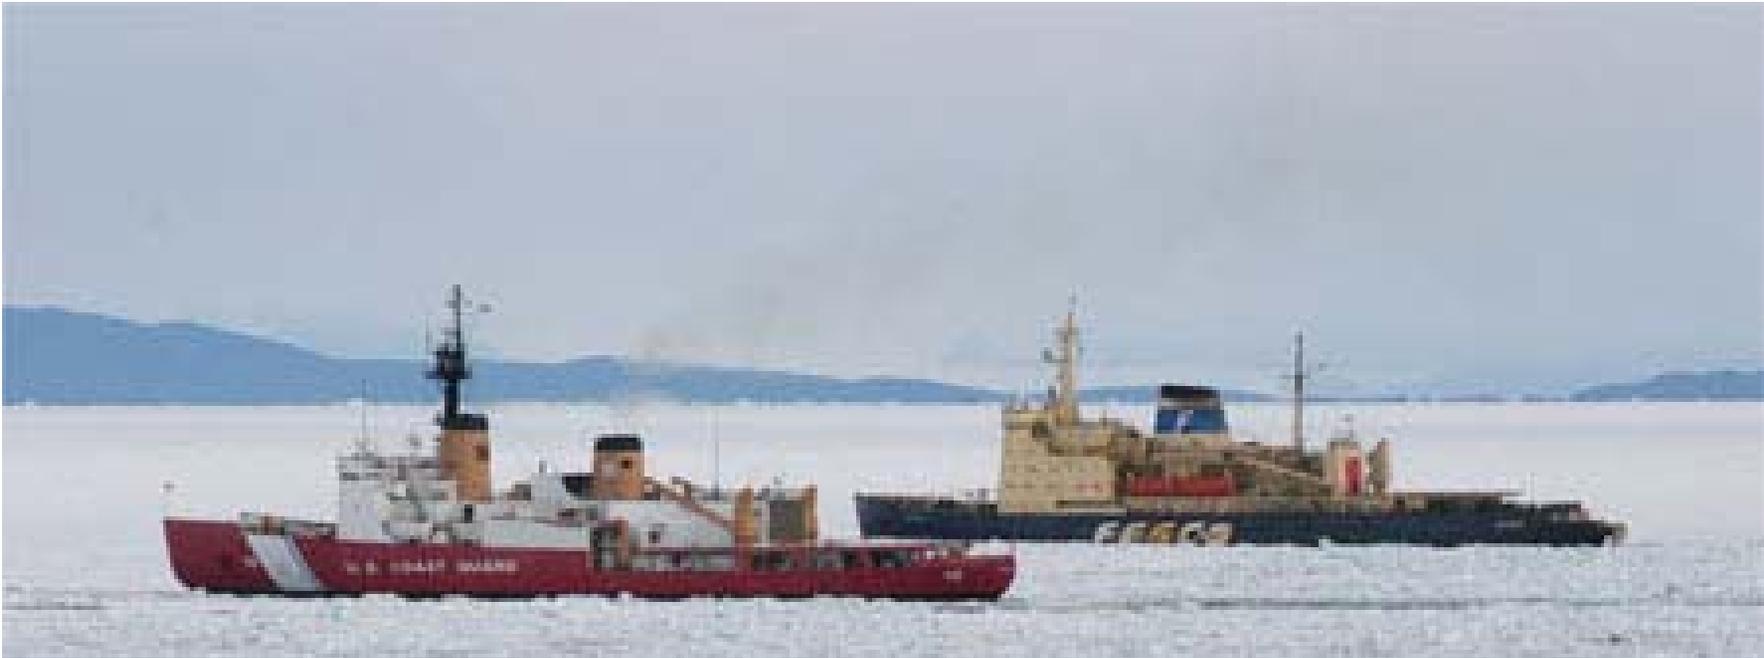
POLAR STAR	KRASIN
Displacement	13,200 tons	20,000 tons
Horsepower	75,000/18,000	36,000
Length	396.6 ft	443 ft
Beam	89.9 ft	85.3 ft
Year Built	1976	1976

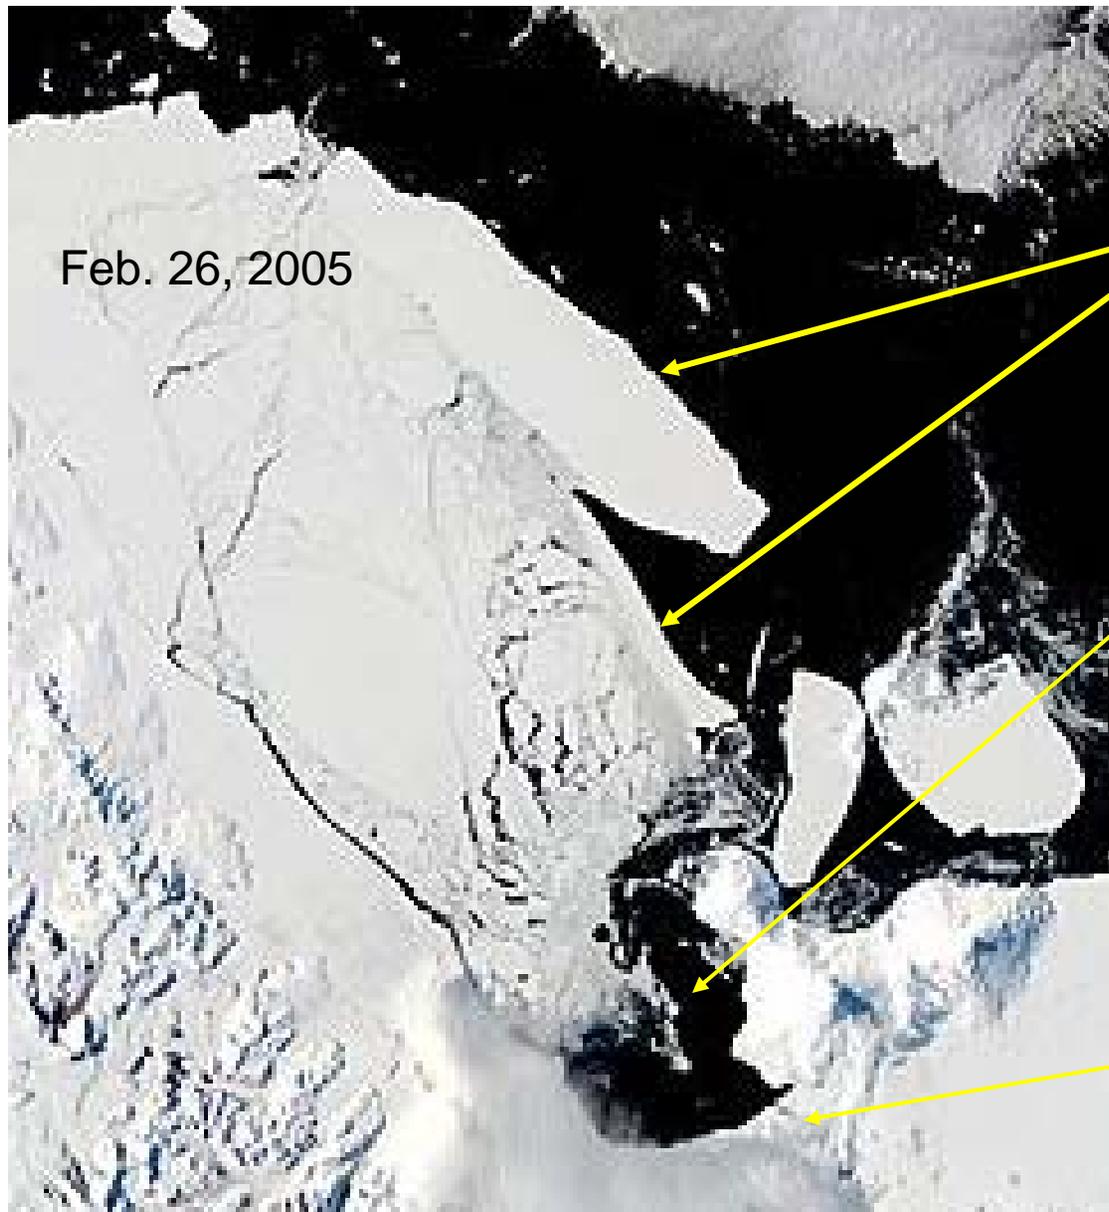
Last Year – Things to Note

Icebergs, B-15A and B15K are effectively blocking northward movement of sea ice

Southern Part of Sound – Open water

Channel did not clear out

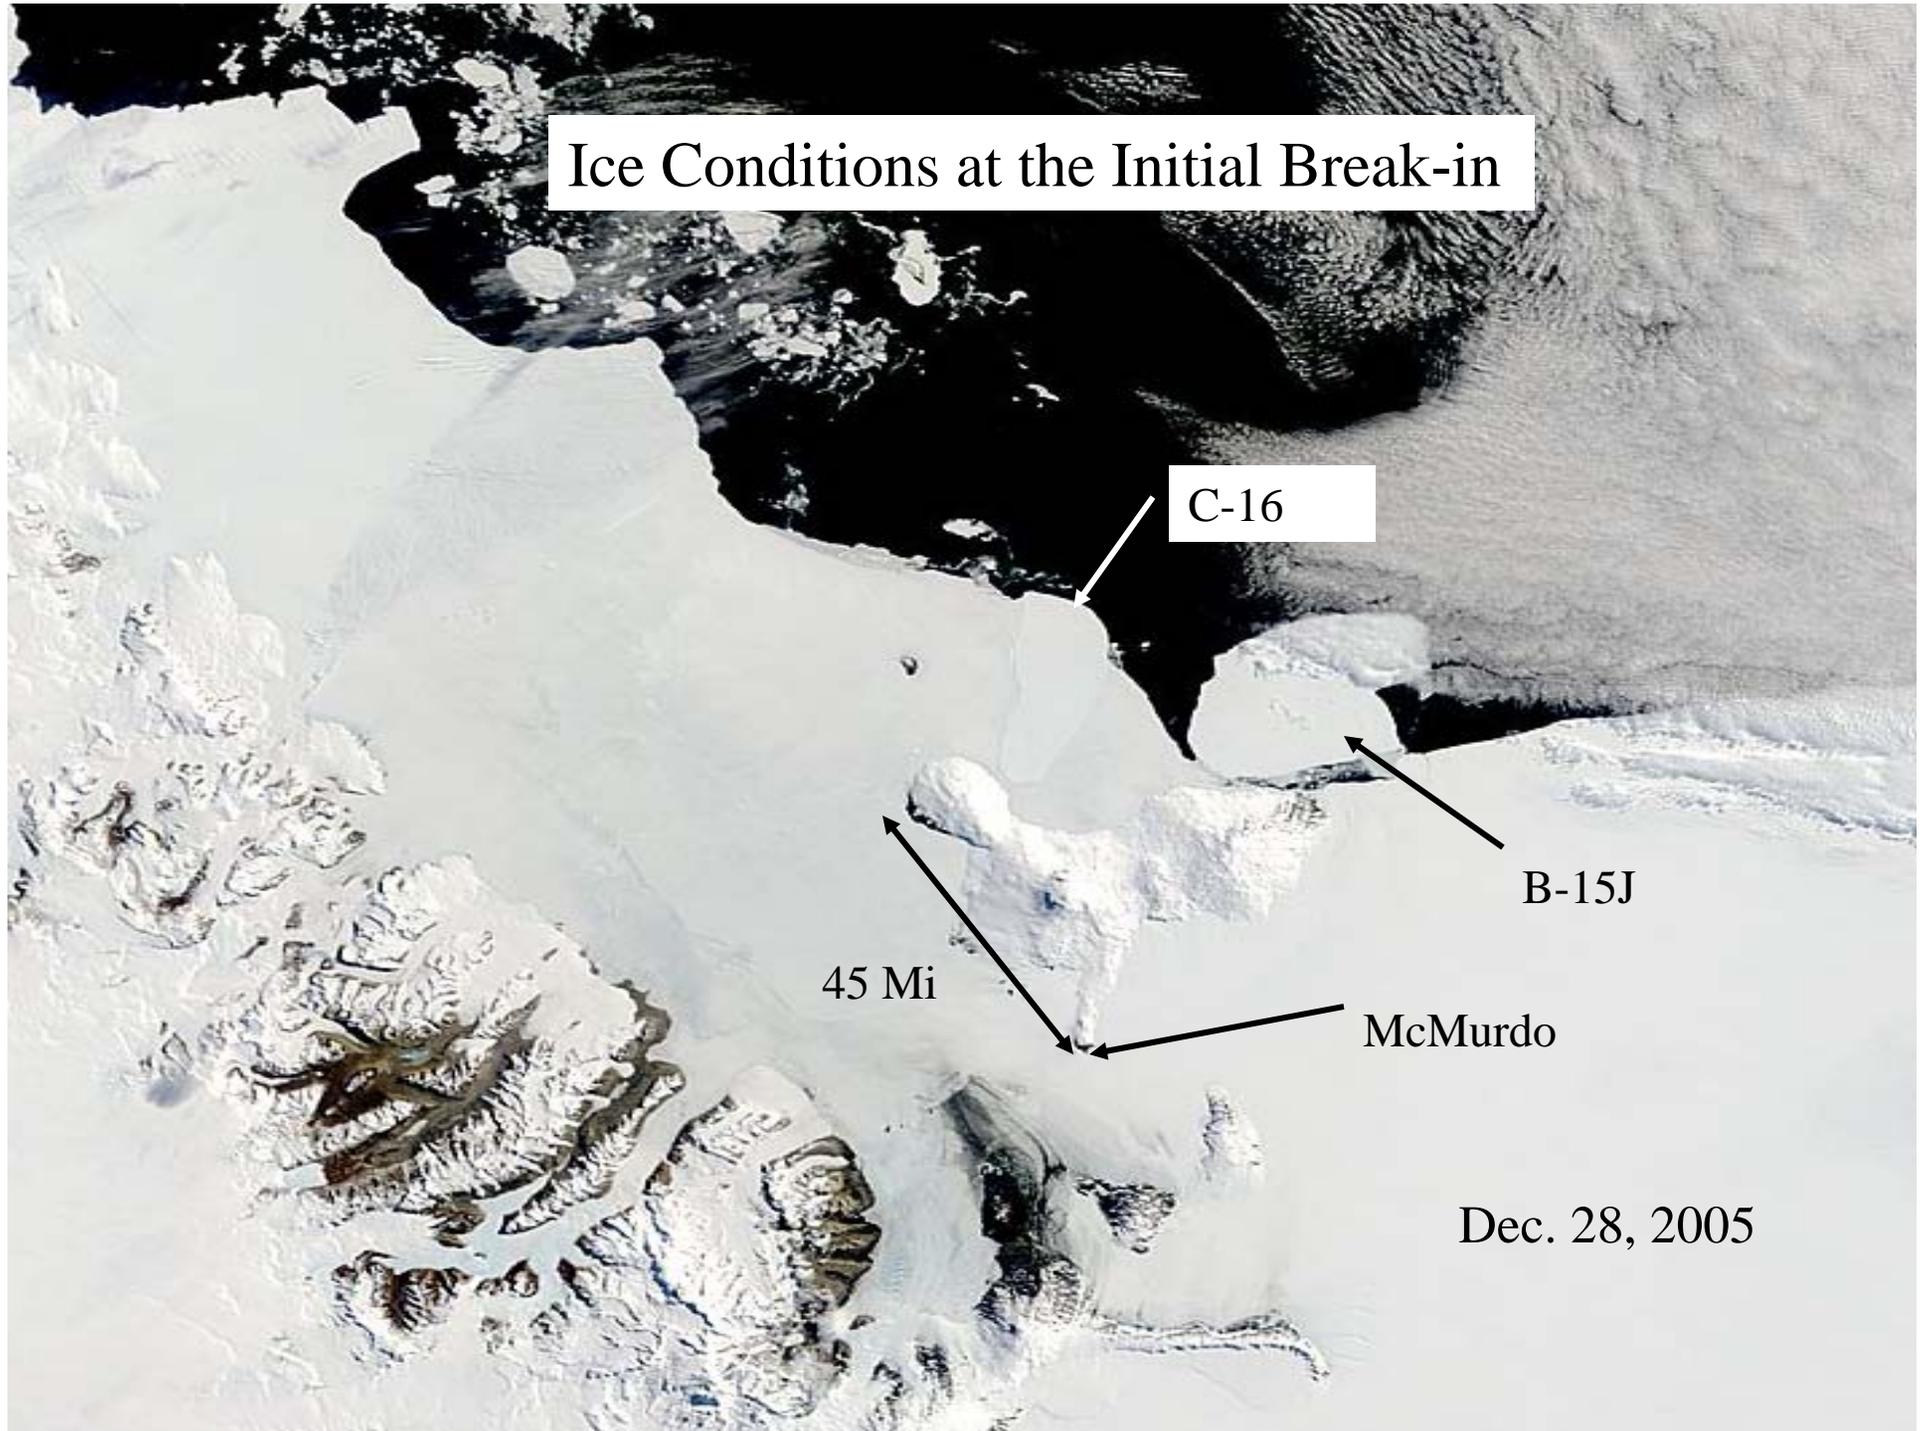
Ice Conditions at the Initial Break-in

C-16

B-15J

45 Mi

McMurdo

Dec. 28, 2005

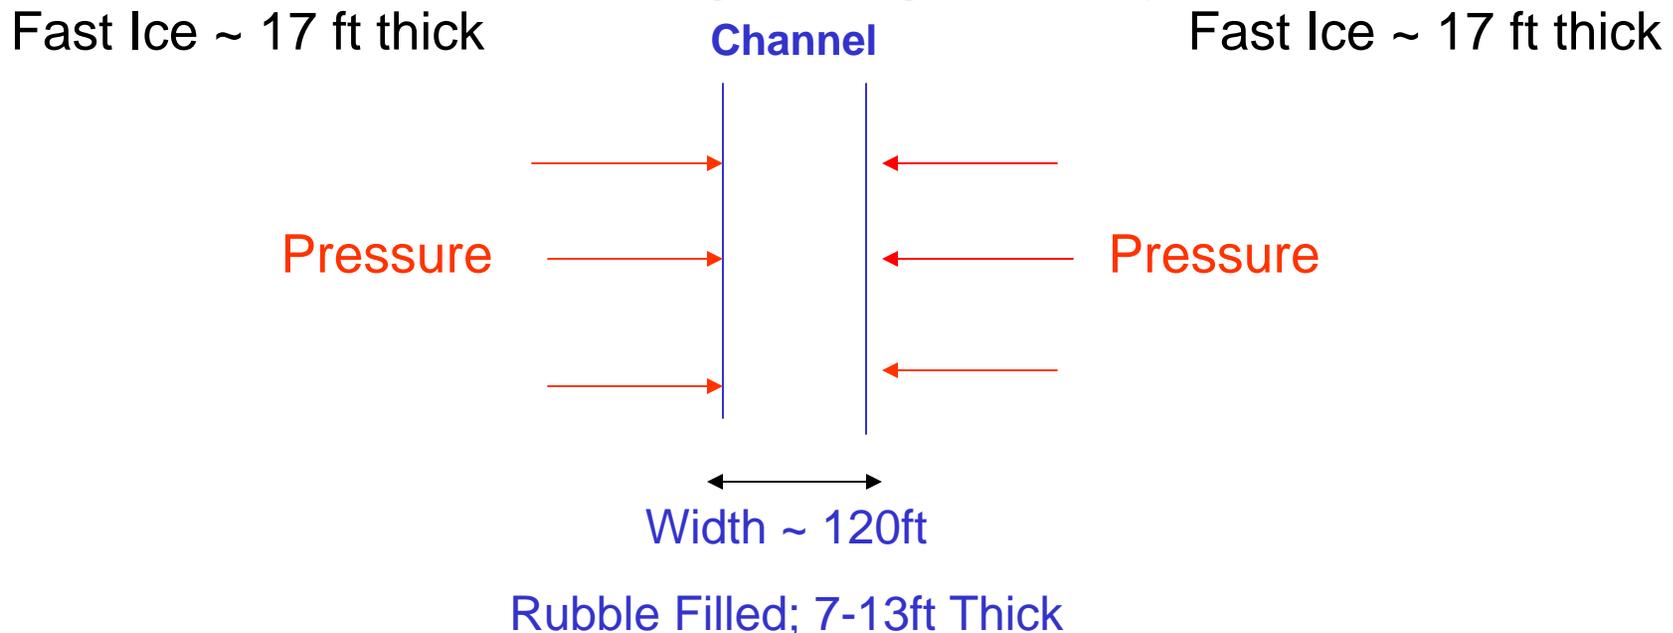
Actual Initial Break-in

- Estimated 5.6 days for “best performance” in expected ice
- Eight days allocated in schedule
- Nine days total for initial break-in
- Difference – Friction Reducing Hull coating on KRASIN (Inerta) mostly gone. Only skill of operators minimized getting stuck.
- Also, channel under unpredicted lateral pressure for the last 14 miles which hampered grooming and delayed escort

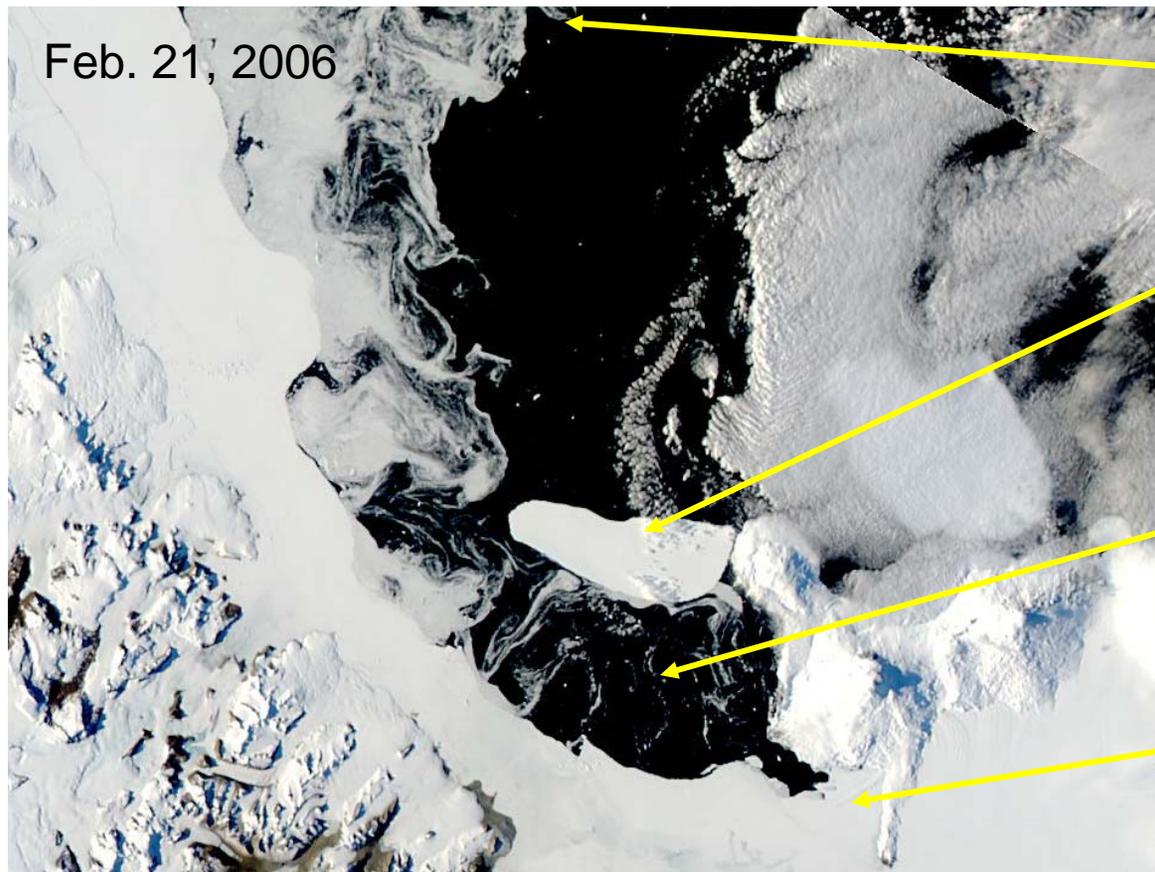
This Year – Things to Note

B-15A&K
Completely
Clear of
McMurdo Sound

C-16 Recently
Moved into
Sound

Southern Part of
Sound – Open Water

Channel has not
yet Cleared out

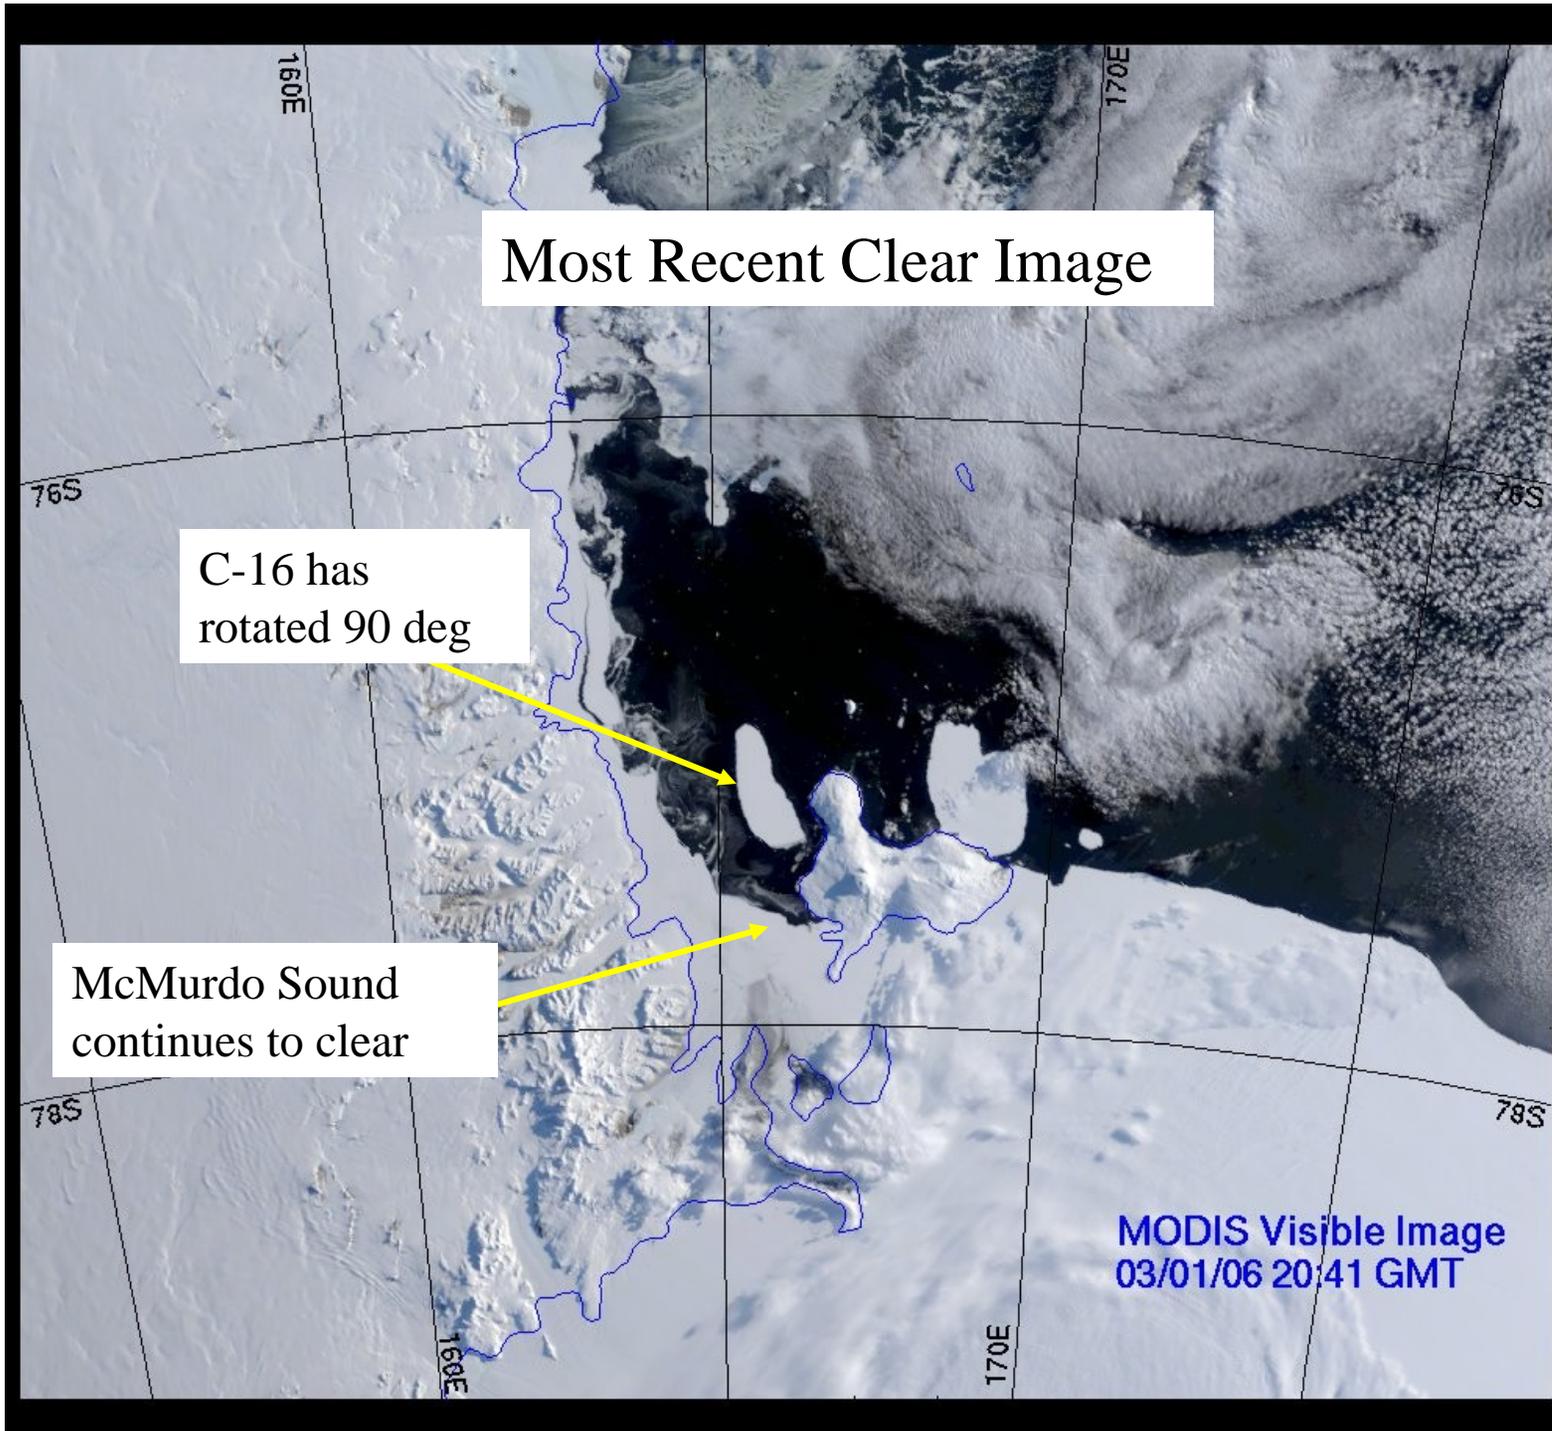
Most Recent Clear Image

C-16 has rotated 90 deg

McMurdo Sound continues to clear

MODIS Visible Image
03/01/06 20:41 GMT
